# CONCEPTUAL DESIGN REPORT

## Wissahickon Reach Restoration

Wissahickon Creek at Chestnut Hill College  
Philadelphia, Pennsylvania

April 16, 2024

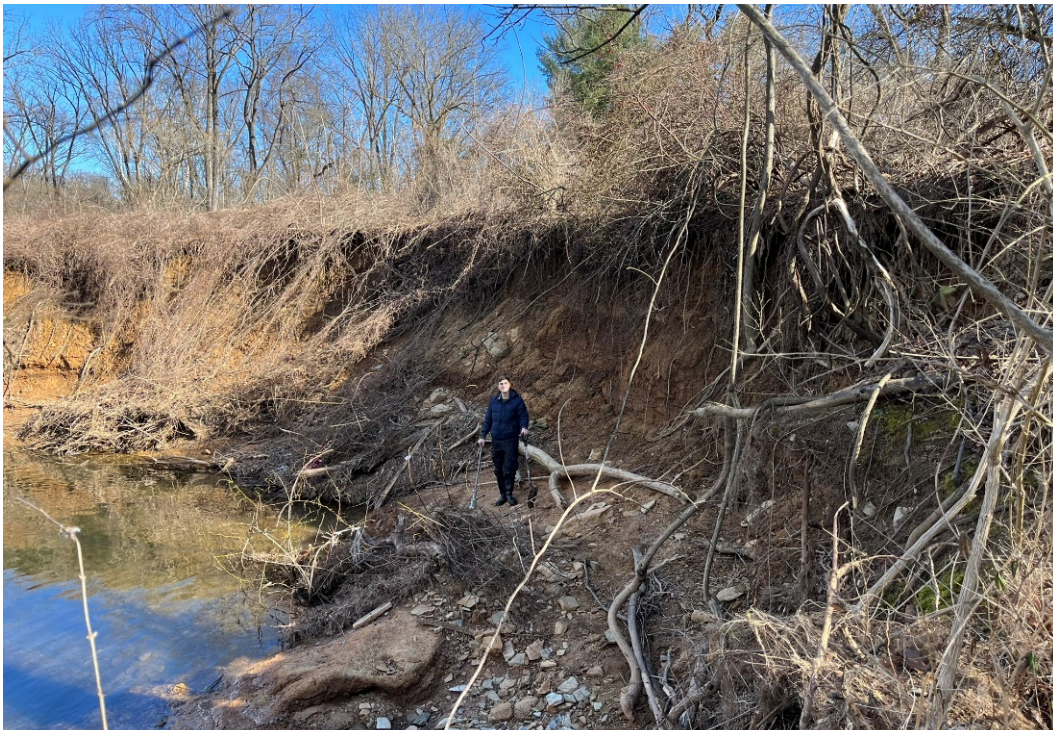
Pictured: Severe streambank erosion along project reach, February 7, 2024.

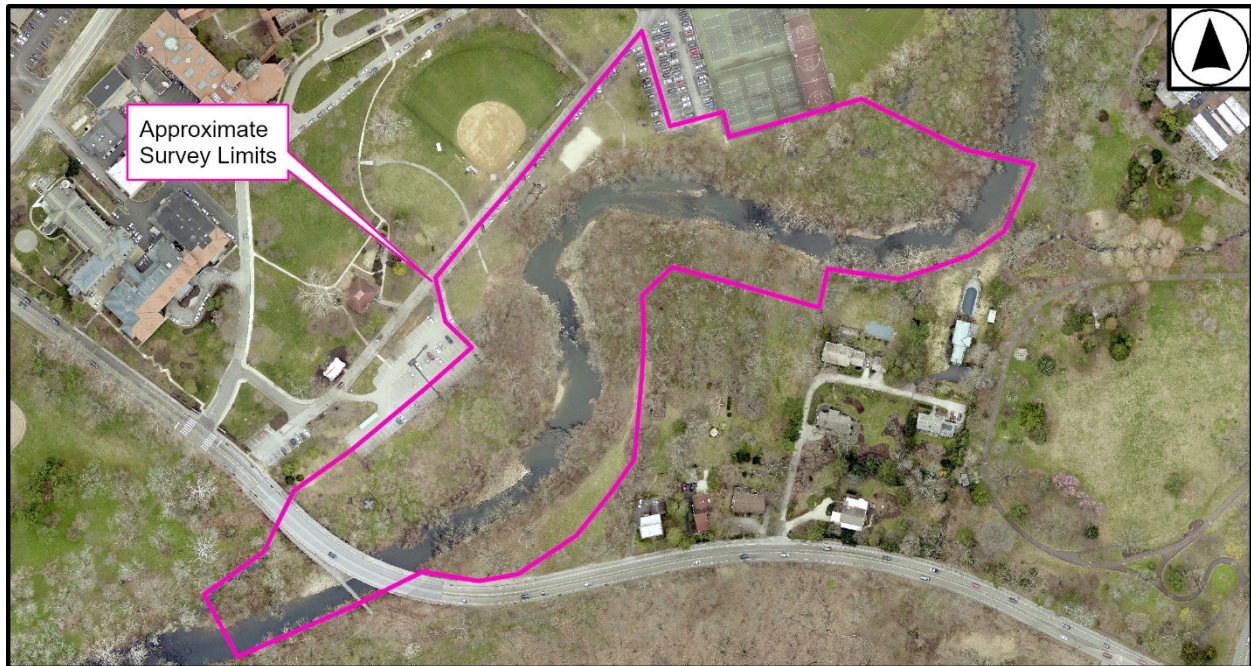
**Figure 2: Topographic Survey Request**

A topographic survey of the project site was performed by Aterra’s subconsultant, Cedarville Engineering Group, LLC (CEG). Survey limits were based on a request prepared by Aterra, shown in Figure 2. Actual topographic survey limits are shown on the Topographic Base Map, included as Appendix A. In the case of the Hollenbeck property, which has chosen to not participate in the project, the project boundary follows the creek bed while all other property owners between Germantown Avenue and the beginning of the Morris Arboretum are included in the survey and related property.

Topography and boundary were established by field survey made upon the ground by CEG in November 2023. Property boundary information was obtained from existing deeds and plans of record, without the benefit of a title report. Features located include existing structures, roadways, curbs, driveways, walks, utility poles and utilities, edge of woods, and other features. The Germantown Avenue bridge structure survey included bridge surface and walls, wingwalls, and low chords. Stream cross sections were field surveyed every 200 feet within the survey limits and include channel bathymetry. Note that the stream survey at the upstream end of the survey limits did not access the upland properties along the left streambank, looking downstream. The vertical and horizontal references used were the North American Vertical Datum of 1988 (NAVD88) and the Pennsylvania South State Plane Coordinate (SPC) System, respectively. A correlation to the Philadelphia City Datum as provided by the Philadelphia District Regulator is included in the Topographic Base Map (Appendix A).

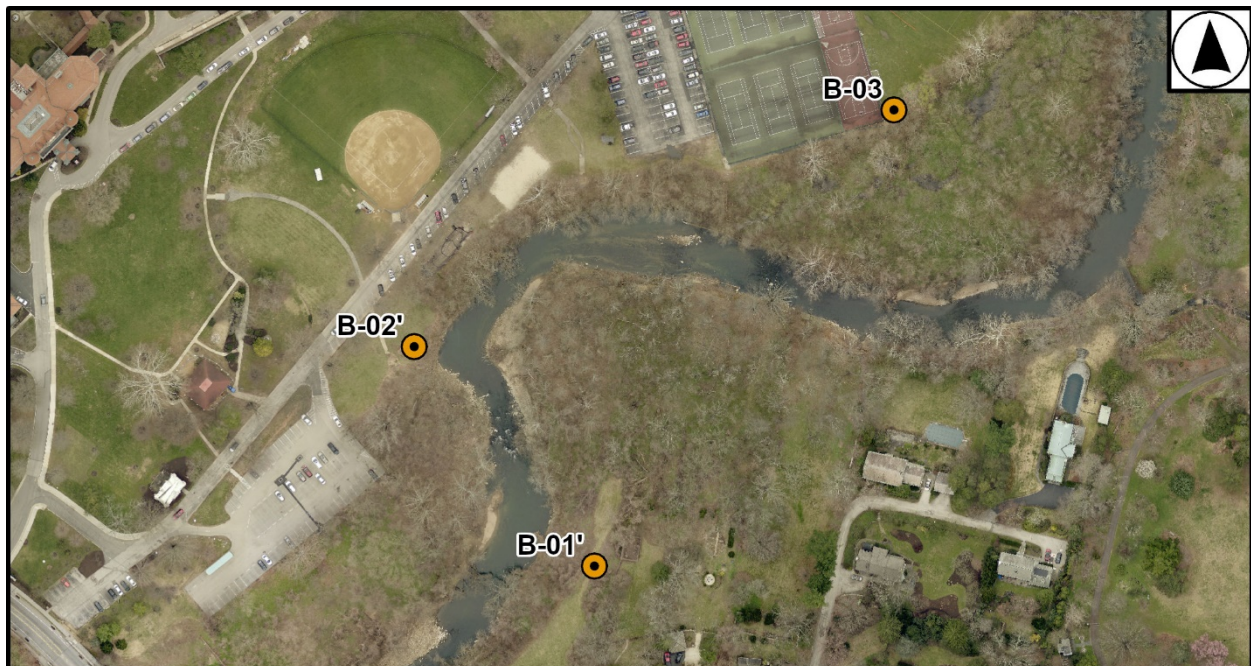
**Figure 3: Borehole Locations**

To support the restoration design effort, three locations along the stream were characterized (B-01, B-02, B-03) by drilling boreholes 20 feet below ground surface (bgs). Drilling operations occurred on December 8, 2023. Soil samples obtained at these locations were identified in the field and verified by laboratory testing performed by American Engineers Group, LLC (AEG). Borehole locations are presented in Figure 3. Boring logs detailing the soil sampling results at specified depths are presented in Appendix B.

Boreholes were backfilled immediately after drilling; therefore, longer-term stabilized water levels were not recorded. Groundwater levels were estimated by noting the depth at which wet soil samples were encountered during drilling. These water levels are presented in Table 3.

Water levels in the boreholes appeared to be consistent with stream elevations based on the observed (not surveyed) ground surface elevations at each borehole. Any excavation activities at the project site will likely encounter groundwater at or below streambank elevations while digging in the vicinity of the creek.

<b>Borehole Location</b>	<b>Ground Surface Elevation (ft NAVD88)*</b>	<b>Depth to Estimated Groundwater Level (ft below ground surface)</b>	<b>Elevation of Estimated Groundwater Level (ft NAVD88)*</b>
B-01	142.0	18.0	124.0
B-02	127.0	10.0	117.0
B-03	132.0	10.0	122.0
